# Environmental Monitoring Data

Project:	Sydney Metro City & Southwest– TSE Works
Document Number:	SMCSWTSE-JCG-TPW-EM-RPT-097496
Reporting Period:	April 2021
Date Published:	11 May 2021

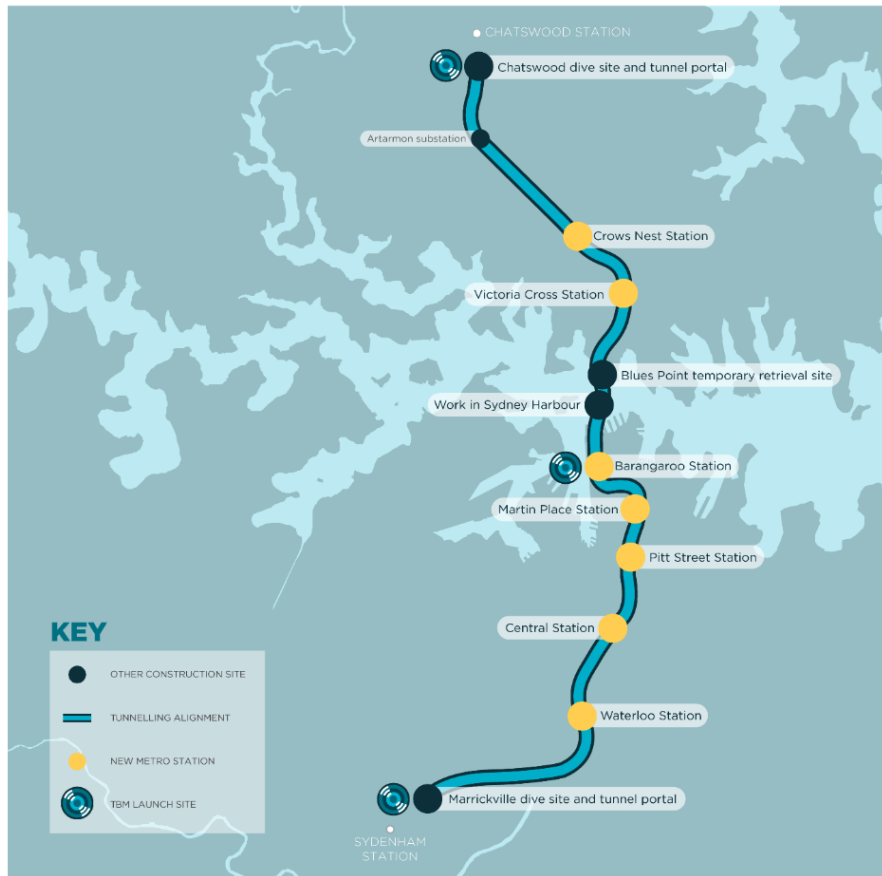
Figure 1: Project Overview

The Sydney Metro City and Southwest is the second portion of the new standalone rail network known as the Sydney Metro which is Australia’s largest public transport infrastructure project and a priority rail project for the NSW Government. John Holland CPB Ghella (JHCPBG) have been contracted by Transport for New South Wales to design and construct the Tunnel and Stations Excavation Works Project (TSE Works) of the Sydney Metro City & Southwest between Chatswood and Sydenham. Figure 1 provides an overview of the Project.
