Environmental Monitoring Data

Project:	Sydney Metro City & Southwest– TSE Works
Document Number:	SMCSWTSE-JCG-TPW-EM-RPT-097485
Reporting Period:	December 2020
Date Published:	13 January 2021

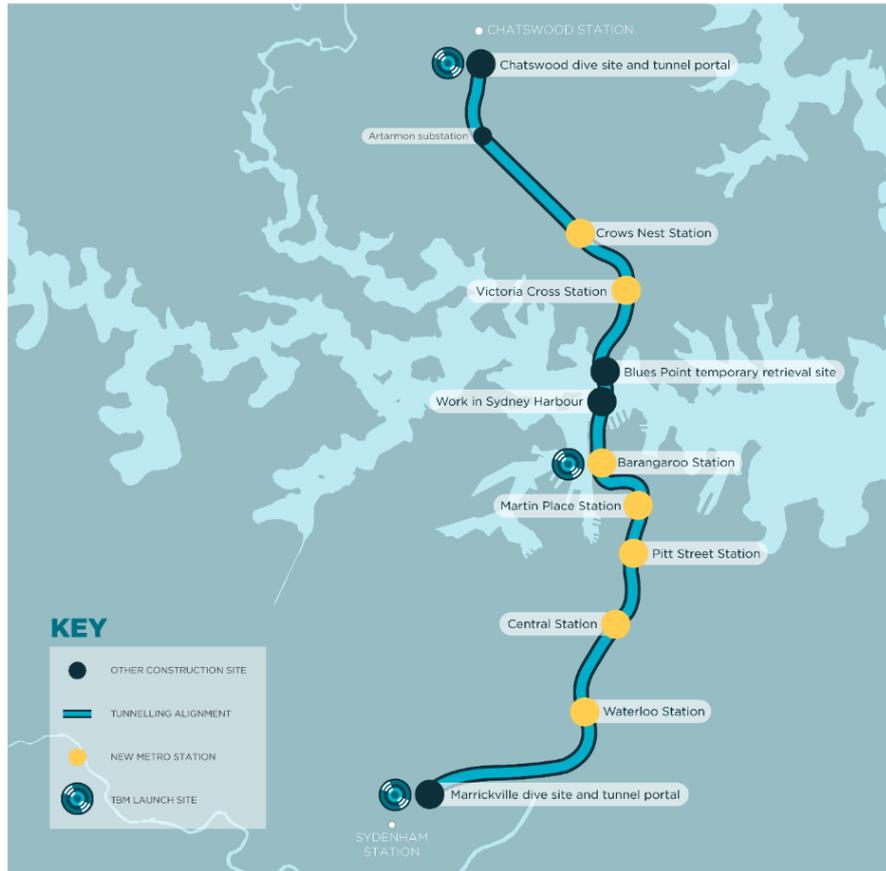
Figure 1: Project Overview

The Sydney Metro City and Southwest is the second portion of the new standalone rail network known as the Sydney Metro which is Australia’s largest public transport infrastructure project and a priority rail project for the NSW Government. John Holland CPB Ghella (JHCPBG) have been contracted by Transport for New South Wales to design and construct the Tunnel and Stations Excavation Works Project (TSE Works) of the Sydney Metro City & Southwest between Chatswood and Sydenham. Figure 1 provides an overview of the Project.
